**DEPARTMENT OF TRANSPORTATION****DIVISION OF ENGINEERING SERVICES**

Contract #: 04-0120F4Cty: SF/ALA Rte: 80 PM: 13.2/13.9File #: 1.28**WELDING INSPECTION REPORT****Resident Engineer:** Siegenthaler, Peter**Address:** 333 Burma Road**City:** Oakland, CA 94607**Report No:** WIR-017072**Date Inspected:** 29-Sep-2010**Project Name:** SAS Superstructure**OSM Arrival Time:** 630**Prime Contractor:** American Bridge/Fluor Enterprises, a JV**OSM Departure Time:** 1500**Contractor:** American Bridge/Fluor Enterprises, a JV**Location:** Jobsite**CWI Name:** See below**CWI Present:** Yes No**Inspected CWI report:** Yes No N/A**Rod Oven in Use:** Yes No N/A**Electrode to specification:** Yes No N/A**Weld Procedures Followed:** Yes No N/A**Qualified Welders:** Yes No N/A**Verified Joint Fit-up:** Yes No N/A**Approved Drawings:** Yes No N/A**Approved WPS:** Yes No N/A**Delayed / Cancelled:** Yes No N/A**Bridge No:** 34-0006**Component:** SAS OBG**Summary of Items Observed:**

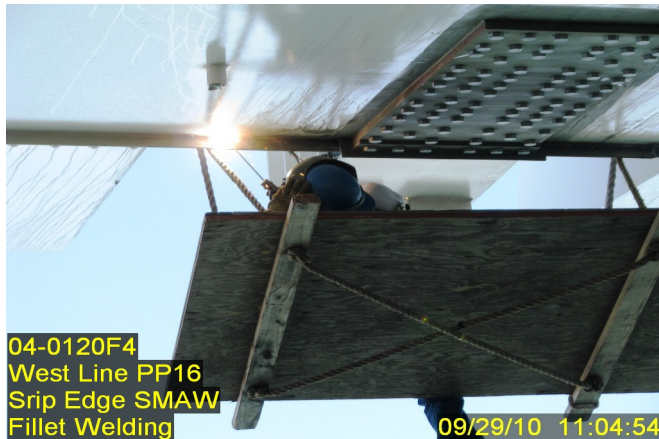
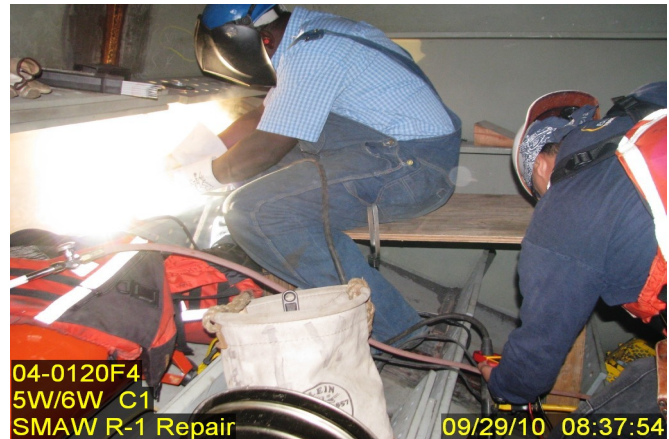
The QAI periodically observed AB/F personnel grinding to excavate R-1 repairs in the OBG Field Splice 5W/6W weld ID: C1 & C2. The QAI periodically observed AB/F approved welder Fred Kaddu (ID 2188) performing repair welding of excavated areas per the SMAW process in the 3G (vertical) position. See photo below. The QAI periodically observed QC Inspector Jesse Cayabyab and later Jim Cunningham were present to monitor the progress and verify that the welding parameters were within the limits established by the approved welding Procedure Specification (WPS) identified as ABF-WPS-D1.5-1000-Repair. The repair welding was in process at this location and the work appeared to be in general compliance with contract documents.
